Voiding under Non-BGA's?

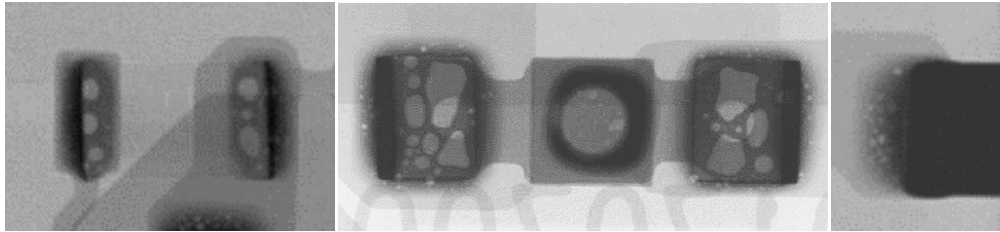
When taking a look at the below pictures, 2 types of voids can be seen:

- ✚ Large voids underneath the component body
- ✚ Small voids in the fillet area around the component

Large voids: For the large voids underneath the component, this is most often caused by outgassing of the solder paste flux. In this case, flux did not have time to escape from underneath the component body. This is quite common and is nearly impossible to fully eliminate without the use of reflowing in vacuum.

Another common cause of voiding can be outgassing of the board through micro-vias embedded in the pads. Outgassing from trapped moisture in the board will flow along the glass fibers in the FR4 and escape upwards at micro-via locations. If these micro-vias are underneath a pad, they will cause voiding and profile modifications often will not be enough. Pre-baking and storing of boards in a Nitrogen environment can help with this root cause of voids.

Small voids in perimeter: The smaller voids in the fillet and underneath are often called "champagne voids" on Immersion Silver substrates. With other plated finishes, the same type of void can occur. During the plating process, if the plating is not performed correctly, contaminants from the plating bath can be plated in with the metal. These contaminants then outgas during the reflow causing small 25-50 micron voids along the surface of the substrate. These are difficult to remove, but profile modifications can help.

However, this flux entrapment can be improved by modifying the reflow profile. The solder paste is composed of roughly 50% flux, and 50% powder by volume (11.5% flux by weight). Of the flux, roughly 50% is solvents that must outgas. Therefore nearly 25% of the solder paste by volume needs to outgas during the reflow profile. By adding a soak zone to the profile, more of this outgassing is allowed to occur prior to reflow. A majority of the volatiles are then removed before the reflow portion of the profile. Increasing the time above liquidus to ~70 seconds can also help allow additional time for any remaining solvents/outgassing to burst out of the molten solder.

Increasing the peak temperature should also be considered, however each application can give different results. By increasing the peak temperature to 245-250C, the solder will become more fluid and thus allow voids to more easily flow through and escape. However at the same time, at temperatures of 250C, more organics may begin to decompose that otherwise would have remained solid at temperatures of 235-240C. Therefore movements in the peak temperature should be trialed to find an optimum for the specific assembly.

Conclusion: Complete elimination of all voids under joints is very difficult without the use of vacuum reflowing. However through profile optimization, a reduction of the voiding should be possible. Unfortunately the void reduction will need to be balanced with solderability and other defects, so the optimized profile for one assembly, may not work on the next. There are no industry specifications as to how much voiding is considered good or bad under passive components. Testing the shear strength of the components can determine if they are in fact reliable. The majority of the joint strength comes from the heal fillets in a joint. However void levels underneath should be monitored as well.
